Myrtle Point Fire

Coos_fir16A

Rapid Visual Screening - Senate Bill #2 - Seismic Needs Assessment
Oregon Department of Geology and Mineral Industries

Coos_fir16B

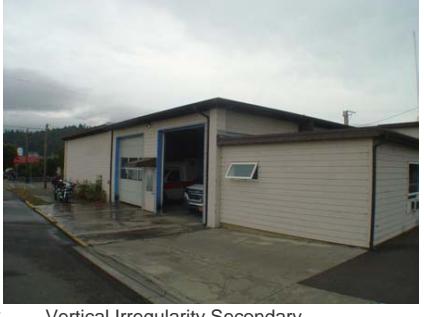
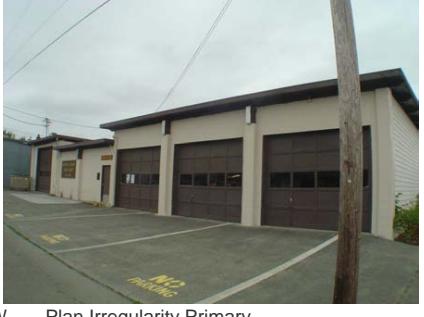
S Vertical Irregularity Secondary Building A is on the left and building B is on the right.		W Plan Irregularity Primary

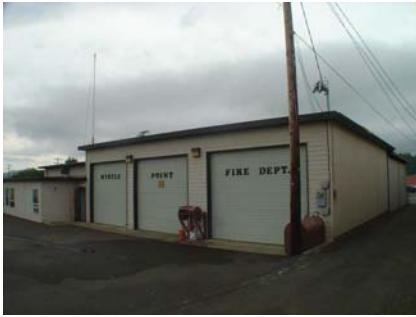
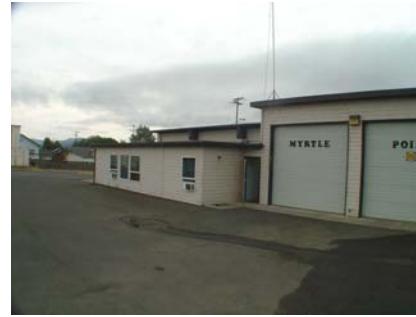
NE Plan Irregularity Primary		E Vertical Irregularity Primary
