Coquille Fire

Coos_fir19A

FEMA 154 Rapid Visual Screening Score Card

Rapid Visual Screening - Senate Bill #2 - Seismic Needs Assessment
Oregon Department of Geology and Mineral Industries

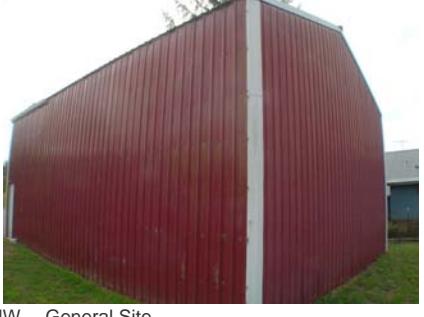
A photograph of a long, single-story building with a red corrugated metal exterior. The building has a gabled roof and a vertical seam in the center. It appears to be a agricultural or industrial structure.			
NW General Site
