# Bandon RFPD

Coos\_fir24A

## FEMA 154 Rapid Visual Screening Score Card

Rapid Visual Screening - Senate Bill #2 - Seismic Needs Assessment  
Oregon Department of Geology and Mineral Industries

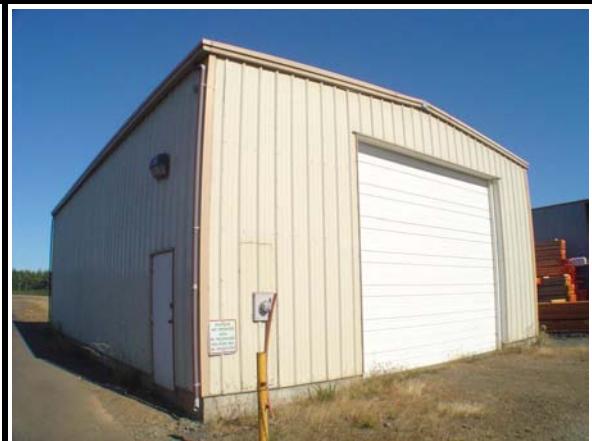
Building Type Fire - RFPD	County Coos	
Street Bandon Airport		
City Bandon	State OR	Zip 97411
Latitude 43.08306	Longitude 124.41008	
Tracking Code RVS in 2006	Inspection Date 8/10/2006

Type	Basic Score	Vert Irreg	Plan Irreg	Pre-Code	Post-Bench	Soil C	Soil D	Soil E	RVS Score
Primary	S3	3.2	0	0	0	0	-0.4	0	0	2.8
Secondary		0	0	0	0	0	0	0	0	0
Tertiary		0	0	0	0	0	0	0	0	0

Final Type	Final Score
S3	2.8

Low (<1%)
