Bandon Police Dept

Coos_pol03A

Building Type Police - City	County Coos	
Street 555 Hwy 101		
City Bandon	State OR	Zip 97411
Latitude 43.11687	Longitude 124.41393	
Tracking Code RVS in 2006	Inspection Date 8/10/2006

Rapid Visual Screening - Senate Bill #2 - Seismic Needs Assessment
Oregon Department of Geology and Mineral Industries

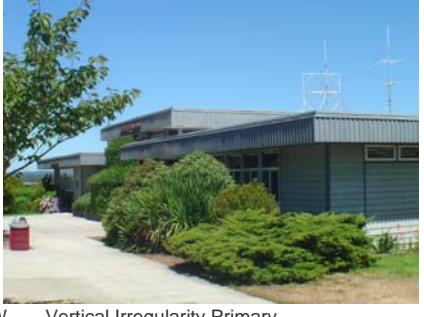
SW	Plan Irregularity Primary	W	Vertical Irregularity Primary

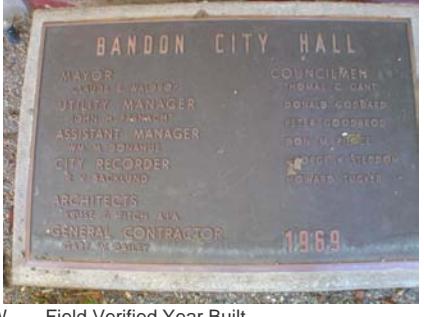
W	Field Verified Year Built

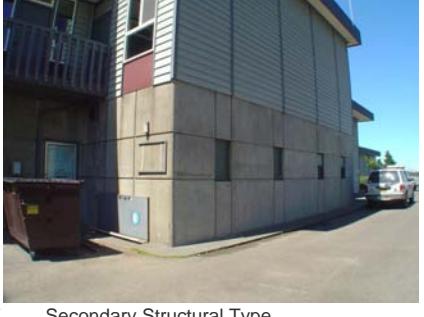
E	Secondary Structural Type
