Myrtle Point Police Department

City of Myrtle Point

Coos_pol08A

FEMA 154 Rapid Visual Screening Score Card

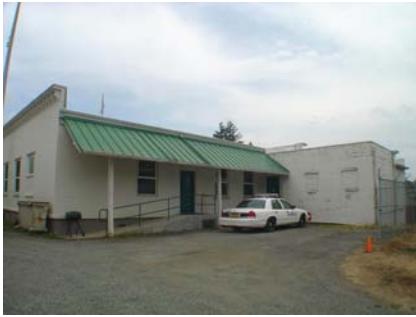
NW Plan Irregularity Primary		N Falling Hazard

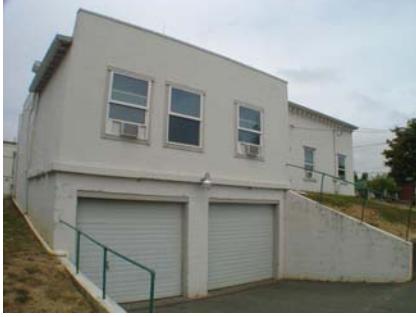
W Vertical Irregularity Primary		S General Site

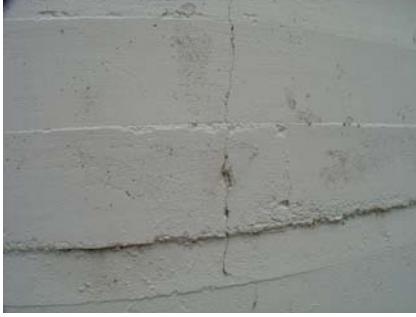
E Field Verified Year Built		S Poor Condition These cracks are all over the building.
