# Myrtle Crest School

Myrtle Point SD 41

Coos\_sch10A

Rapid Visual Screening - Senate Bill #2 - Seismic Needs Assessment  
Oregon Department of Geology and Mineral Industries

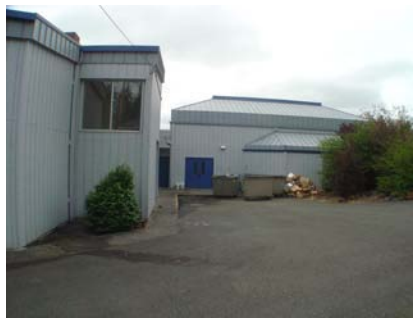
| Reentrant Corners: Other | Steps in Elevation View: Very Irregular Changes |

N Plan Irregularity Primary

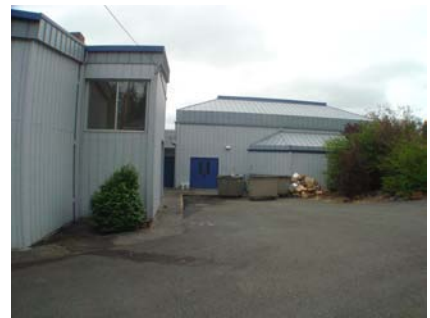
| Out of Plane Lateral-Force-Resistance Elements | None |

N Plan Irregularity Secondary

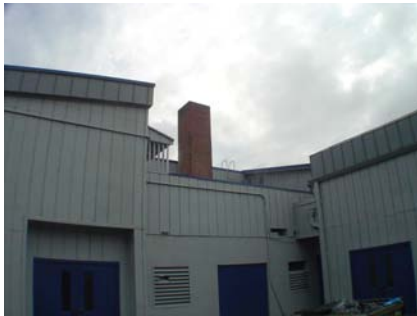
| Unreinforced Chimneys | None |

N Falling Hazard

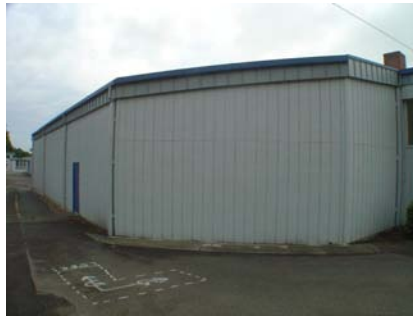
| Non-Parallel System | None |

E Plan Irregularity Tertiary

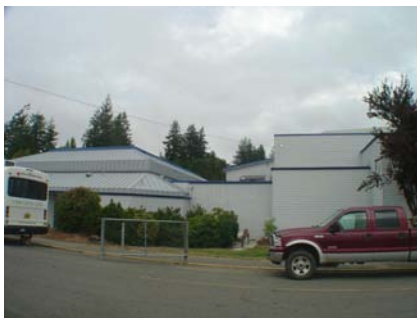
W Vertical Irregularity Primary

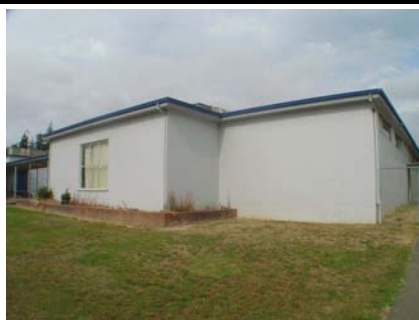
| Out of Plane Lateral-Force-Resistance Elements | Steps in Elevation View: Single Change (Adjacent Building/Entity) |

W Plan Irregularity Primary
