Myrtle Point High School

Coos_sch11A

FEMA 154 Rapid Visual Screening Score Card

Rapid Visual Screening - Senate Bill #2 - Seismic Needs Assessment
Oregon Department of Geology and Mineral Industries

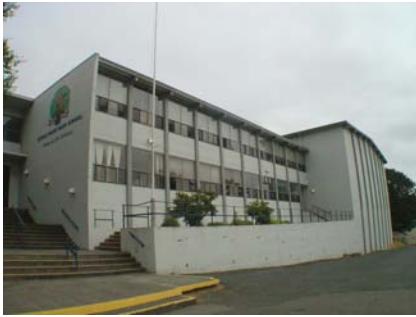
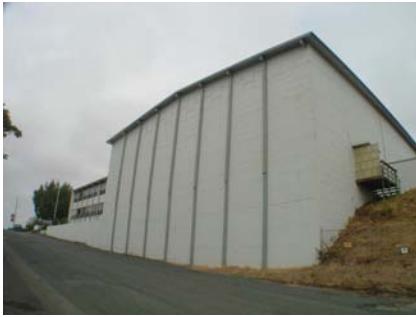
W Secondary Structural Type		W Vertical Irregularity Secondary

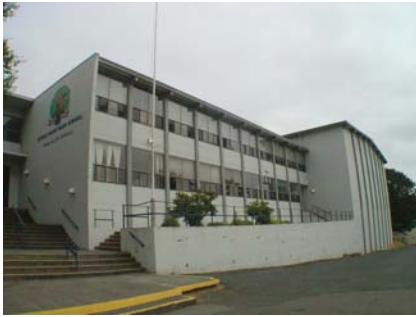
W Plan Irregularity Primary

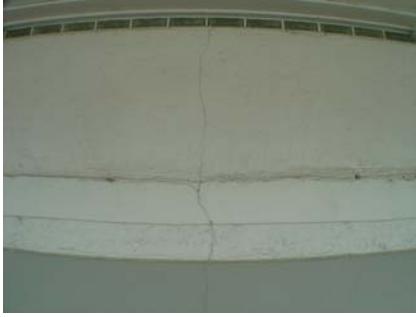
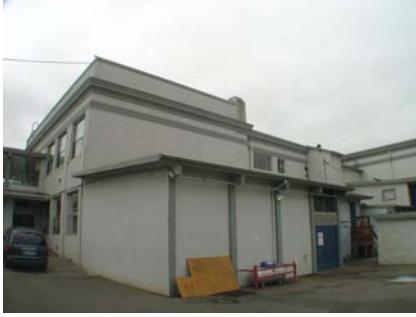
N Poor Condition		E Vertical Irregularity Primary

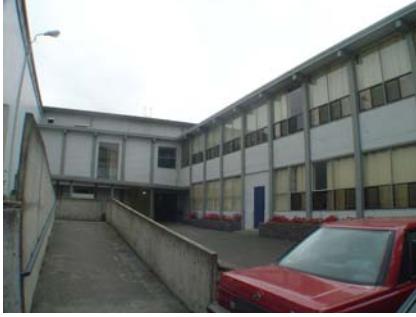
E Plan Irregularity Primary

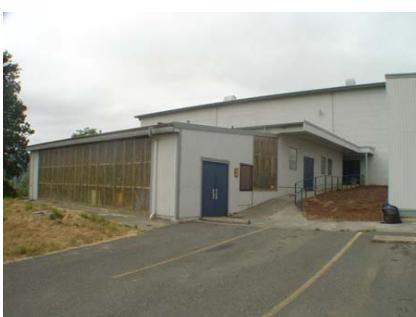
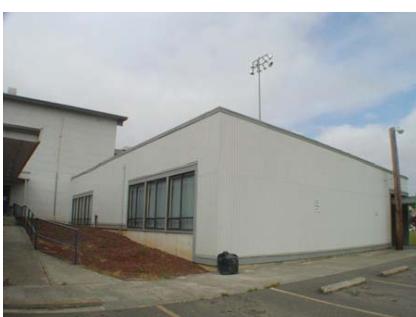
S Plan Irregularity Tertiary		S Vertical Irregularity Tertiary

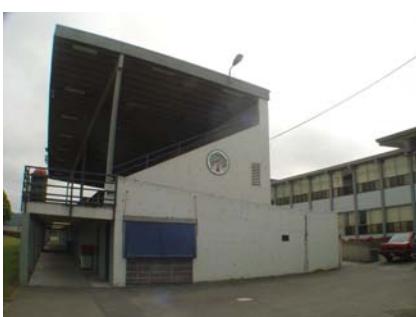
E Other Bleachers are on top of some classrooms.

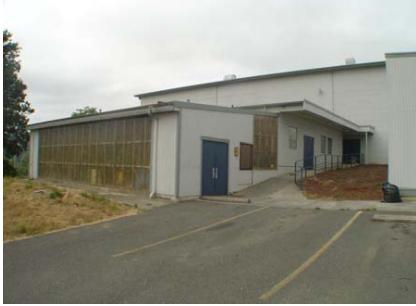
S Plan Irregularity Primary

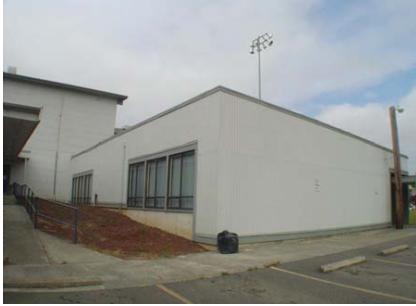
S Plan Irregularity Primary

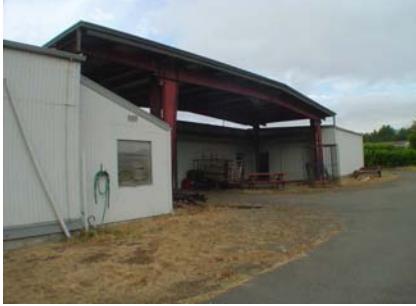
S Plan Irregularity Primary

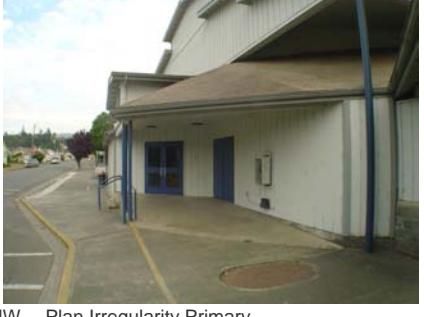
NW Plan Irregularity Primary
