# Harbor Lights Middle School

Coos\_sch12A

## FEMA 154 Rapid Visual Screening Score Card

Rapid Visual Screening - Senate Bill #2 - Seismic Needs Assessment  
Oregon Department of Geology and Mineral Industries

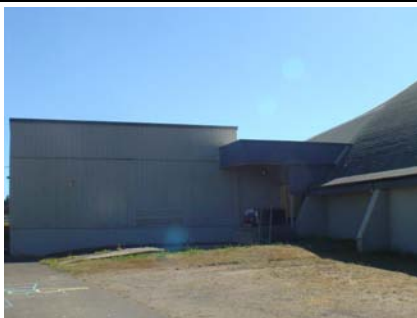
Plan Irregularities	Vertical Irregularities
Reentrant Corners: T shaped	Steps in Elevation View: Single Change
None	None
None	None

NE Vertical Irregularity Primary

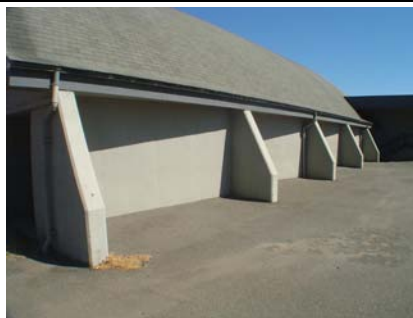
NW Secondary Structural Type

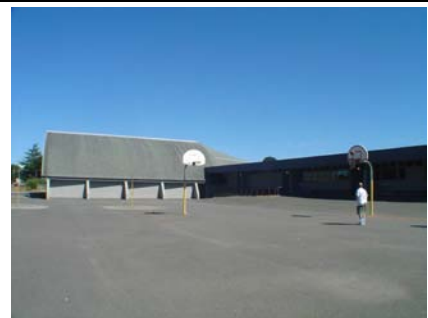
NW Plan Irregularity Primary
