# Ocean Crest Elementary School

Coos\_sch13A

## FEMA 154 Rapid Visual Screening Score Card

Rapid Visual Screening - Senate Bill #2 - Seismic Needs Assessment  
Oregon Department of Geology and Mineral Industries

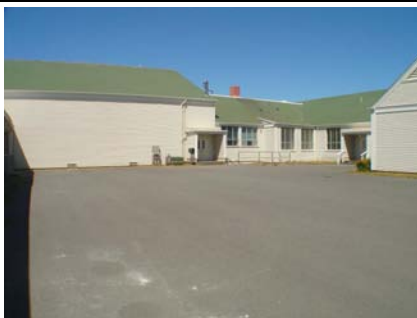
SW Plan Irregularity Primary

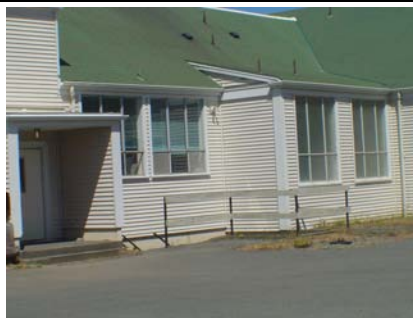
W Plan Irregularity Tertiary

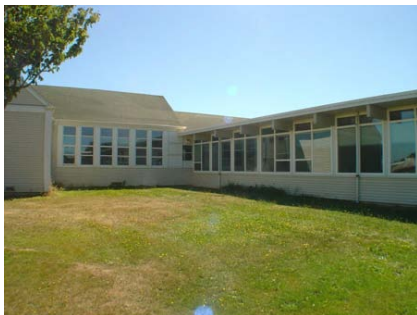
N Plan Irregularity Tertiary

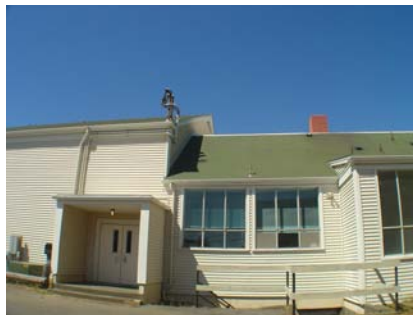
SW Vertical Irregularity Primary

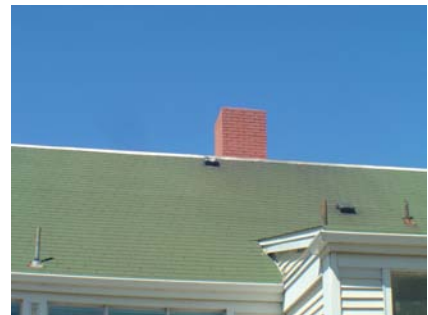
S Falling Hazard

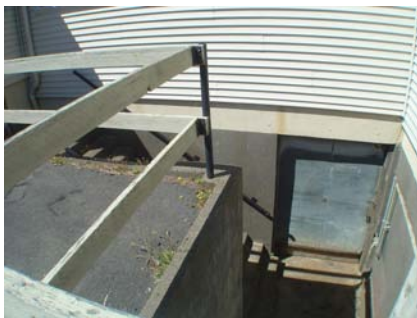
S Basement
