Bandon Senior High School

Coos_sch14A

Rapid Visual Screening - Senate Bill #2 - Seismic Needs Assessment
Oregon Department of Geology and Mineral Industries

Coos_sch14B

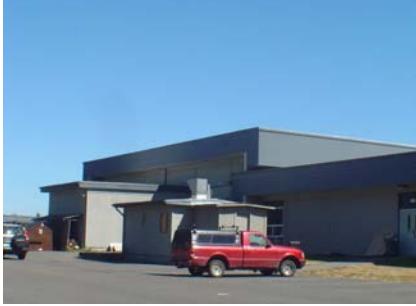
Enrollment 292	Year Built (Field Verified) 1975	Year Built (Alt. Source) 1970	Est. Decade Built 1970
Total Area (square ft) 60140	Number of Stories 1	Basement	Pounding Potential No
Plan Irregularities Reentrant Corners: Other None None		Vertical Irregularities Steps in Elevation View: 2 to 3 Changes None None	
Falling Hazards None None None		Poor Conditions None None None

N Vertical Irregularity Primary		NE Plan Irregularity Primary

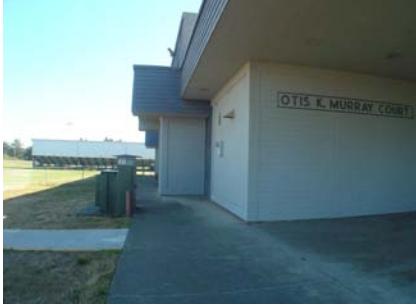
Enrollment 292	Year Built (Field Verified) 1975	Year Built (Alt. Source) 1970	Est. Decade Built 1970
Total Area (square ft) 60140	Number of Stories 1	Basement	Pounding Potential No
Plan Irregularities		Vertical Irregularities	
Reentrant Corners: Other		Steps in Elevation View: 2 to 3 Changes	
Out of Plane Lateral-Force-Resistance Elements		None	
None		None	
Falling Hazards		Poor Conditions	
None		None	
None		None	
None		None

E Plan Irregularity Secondary		SE Vertical Irregularity Primary

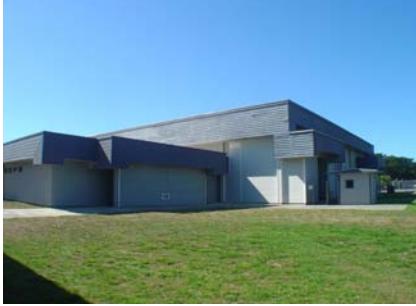
SE Plan Irregularity Primary
