Resource Link Charter School

Coos Bay SD 9

FEMA 154 Rapid Visual Screening Score Card

Rapid Visual Screening - Senate Bill #2 - Seismic Needs Assessment
Oregon Department of Geology and Mineral Industries

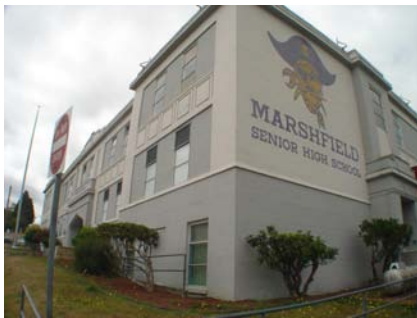
NE Vertical Irregularity Primary

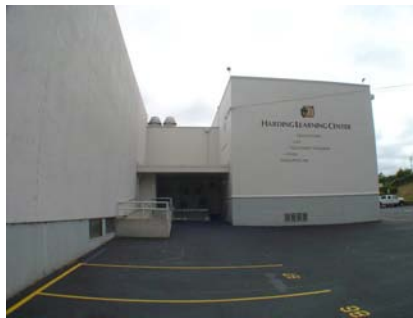
W Plan Irregularity Primary
