Pacific Child Care Center

North Bend SD 13

Coos_sch23A

Rapid Visual Screening - Senate Bill #2 - Seismic Needs Assessment
Oregon Department of Geology and Mineral Industries

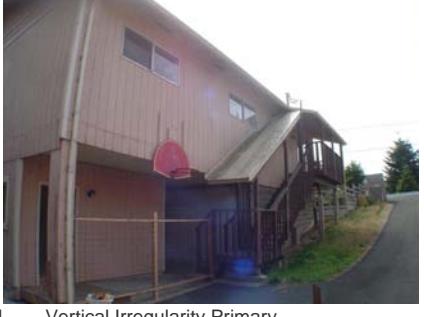
| N Vertical Irregularity Primary sloped site | | E General Site | |

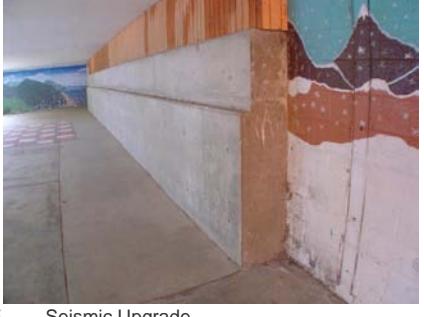
| | | E Seismic Upgrade Building was settling on the east side and this footing was placed. Most of the soil at this site looks like a fine sand. | |
