Pioneer Memorial Hospital - Prineville

Croo_hos01A

FEMA 154 Rapid Visual Screening Score Card

Rapid Visual Screening - Senate Bill #2 - Seismic Needs Assessment
Oregon Department of Geology and Mineral Industries

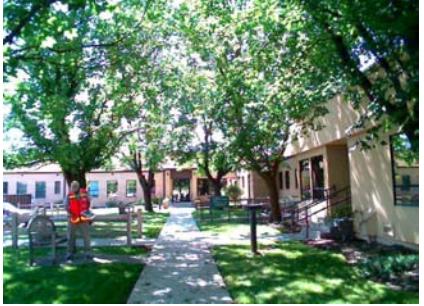
E Elevation View		E Plan Irregularity Primary

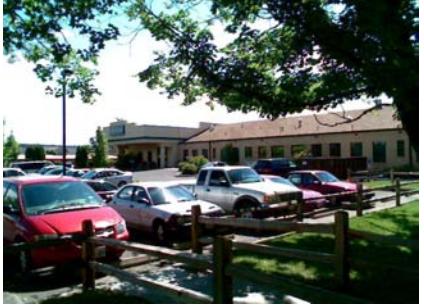
NE Plan Irregularity Secondary

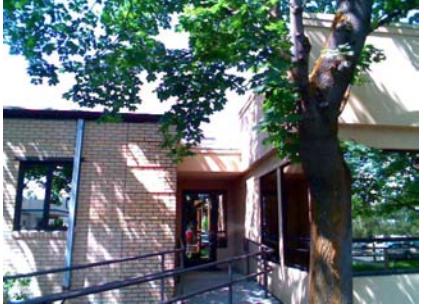
S	Vertical Irregularity Primary

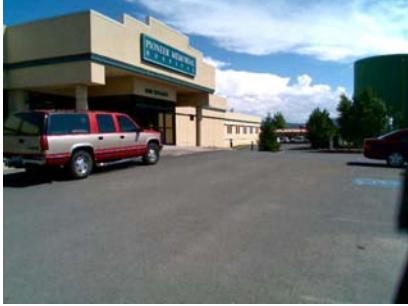
NW General Site		NE Elevation View
