Cedar Valley Fire Department

Curr_fir14A

FEMA 154 Rapid Visual Screening Score Card

Rapid Visual Screening - Senate Bill #2 - Seismic Needs Assessment
Oregon Department of Geology and Mineral Industries

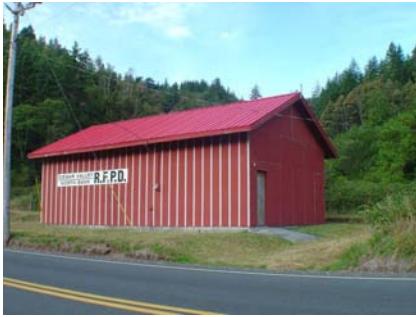
| NE General Site | | | |

| Torsion: Eccentric Stiffness | | None | |
