Gold Beach High School

Curr_sch04A

FEMA 154 Rapid Visual Screening Score Card

Rapid Visual Screening - Senate Bill #2 - Seismic Needs Assessment
Oregon Department of Geology and Mineral Industries

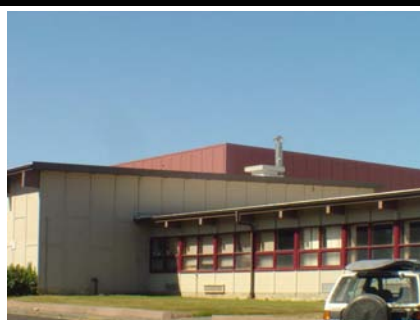
E Vertical Irregularity Primary

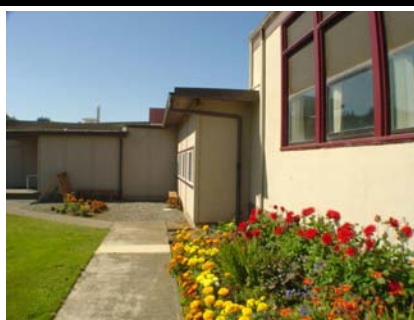
E Plan Irregularity Secondary

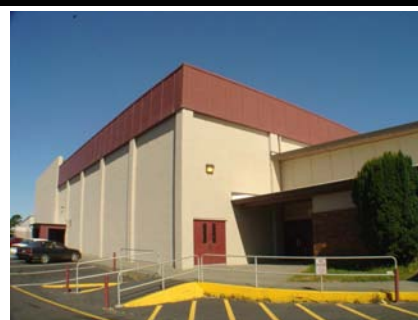
S Secondary Structural Type

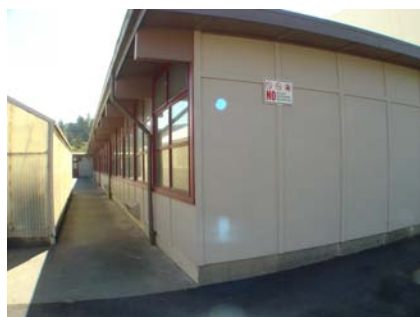
W Plan Irregularity Primary
primary structural type

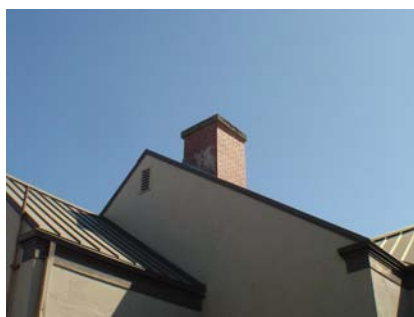
W Falling Hazard
original 1920's bldg at north end of "A"

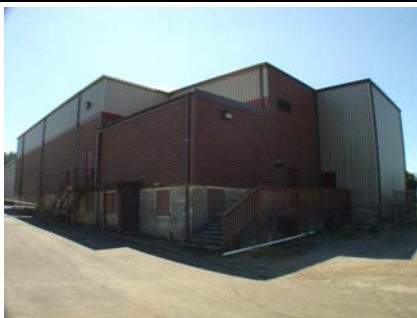
NW Vertical Irregularity Primary

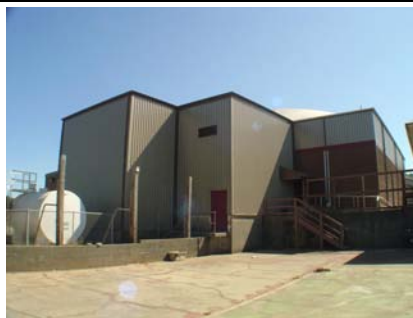
SW Plan Irregularity Primary

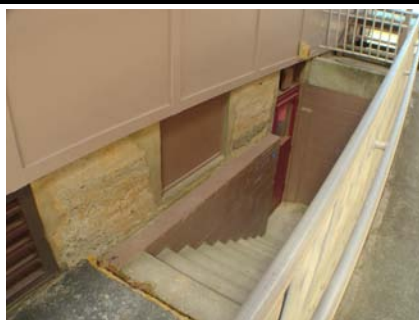
N Vertical Irregularity Primary
First floor

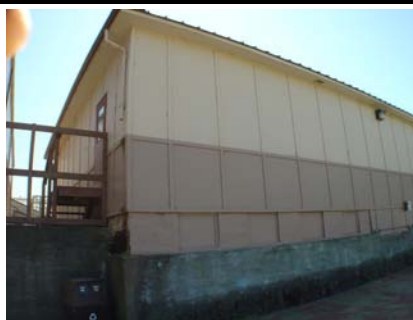
NW Vertical Irregularity Primary
