# Driftwood Elementary School

Port Orford-Langlois SD 2CJ

## FEMA 154 Rapid Visual Screening Score Card

Rapid Visual Screening - Senate Bill #2 - Seismic Needs Assessment  
Oregon Department of Geology and Mineral Industries

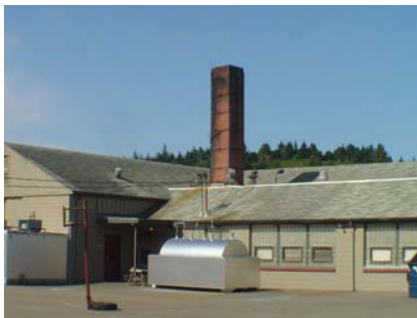
E Falling Hazard  
This is partially-reinforced

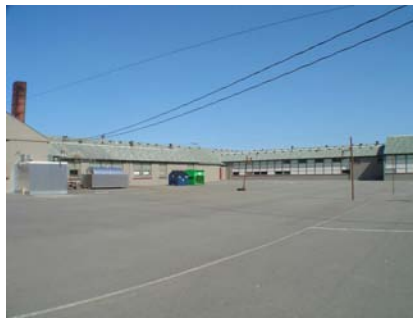
SE Plan Irregularity Primary

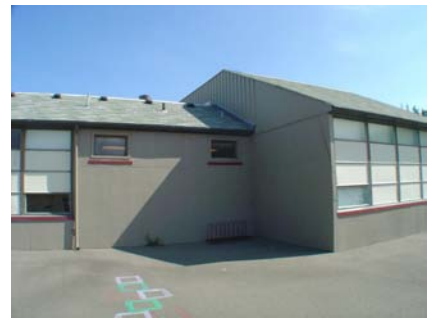
S Vertical Irregularity Primary

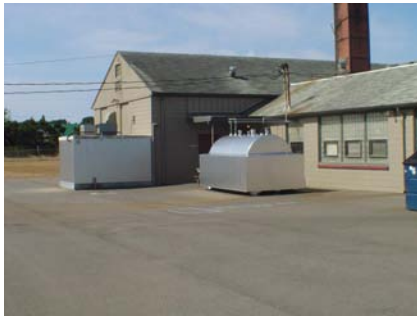
E Plan Irregularity Secondary

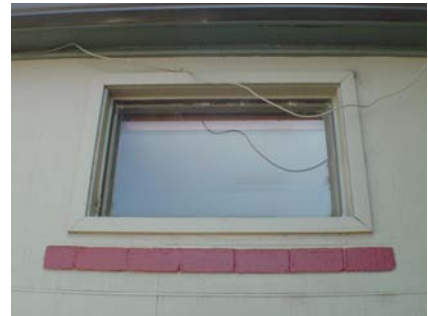
S Other structural type
