# Blanco School

Port Orford-Langlois SD 2CJ

## FEMA 154 Rapid Visual Screening Score Card

Rapid Visual Screening - Senate Bill #2 - Seismic Needs Assessment  
Oregon Department of Geology and Mineral Industries

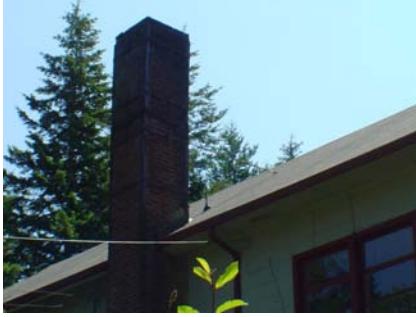
N Falling Hazard	E Plan Irregularity Secondary
