Black Butte RFPD

Desc_fir01A

FEMA 154 Rapid Visual Screening Score Card

Rapid Visual Screening - Senate Bill #2 - Seismic Needs Assessment
Oregon Department of Geology and Mineral Industries

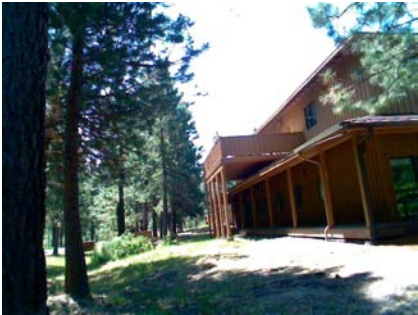
E Primary Structural Type
falling hazard?

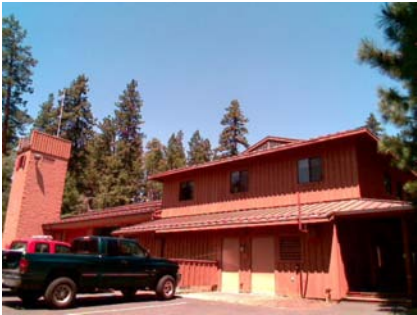
W Vertical Irregularity Primary

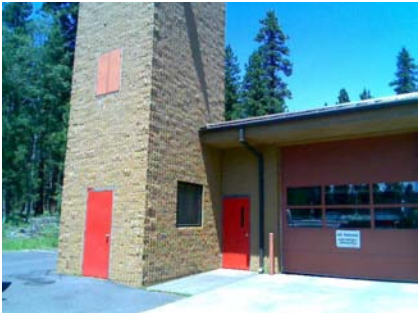
W Plan Irregularity Primary
