# Sisters-Camp Sherman RFPD

Desc\_fir05A

Building Type		County	
Fire - RFPD		Deschutes	
Street			
301 S Elm			
City	State	Zip	
Sisters	OR	97759	
Latitude		Longitude	
44.28942		121.55033	
Tracking Code		Inspection Date	
RVS in 2006		6/27/2006

Rapid Visual Screening - Senate Bill #2 - Seismic Needs Assessment  
Oregon Department of Geology and Mineral Industries

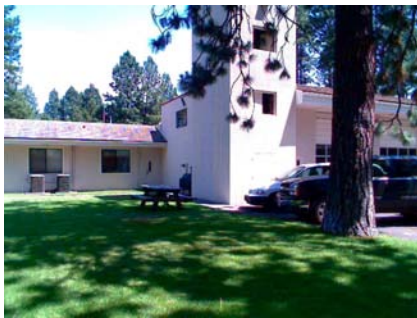
NW Vertical Irregularity Primary

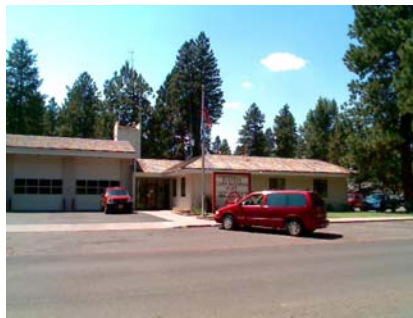
E Elevation View
