# LaPine Senior High School

Bend-LaPine SD 1

## FEMA 154 Rapid Visual Screening Score Card

Rapid Visual Screening - Senate Bill #2 - Seismic Needs Assessment  
Oregon Department of Geology and Mineral Industries

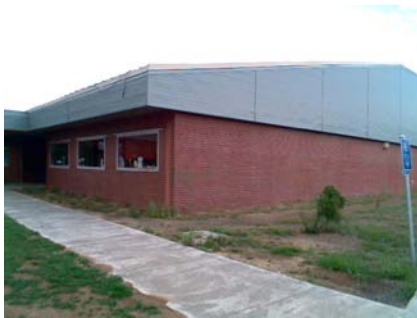
SE General Site

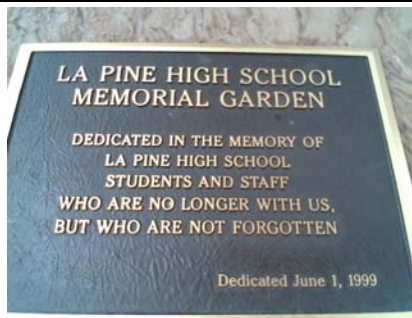
S Other  
addition

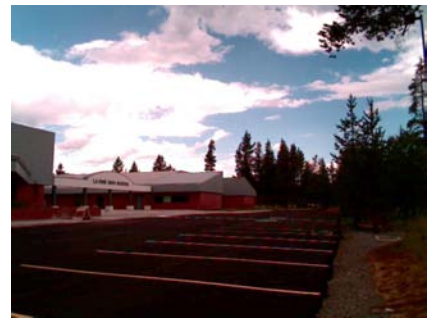
SW General Site

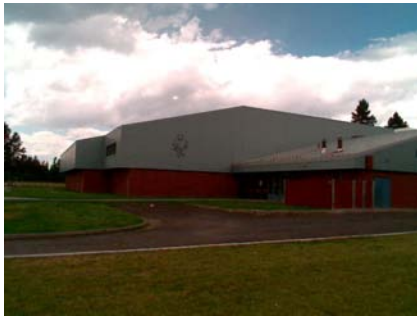
Plan Irregularities	Vertical Irregularities
Reentrant Corners: Other	Steps in Elevation View: 2 to 3 Changes
None	None
None	None

SW Plan Irregularity Primary

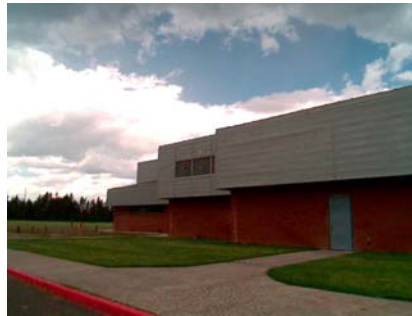
SW Vertical Irregularity Primary

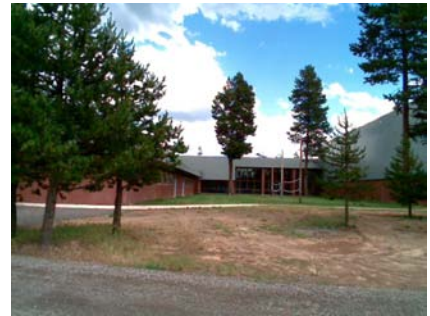
W General Site  
addition in center
