Evergreen Elementary School

Redmond SD 2J

FEMA 154 Rapid Visual Screening Score Card

Rapid Visual Screening - Senate Bill #2 - Seismic Needs Assessment
Oregon Department of Geology and Mineral Industries

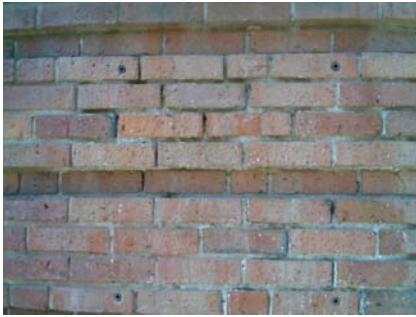
E Primary Structural Type headers forming an english bond

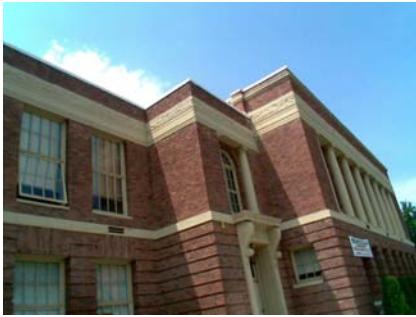
SE Falling Hazard cornice ,parapet

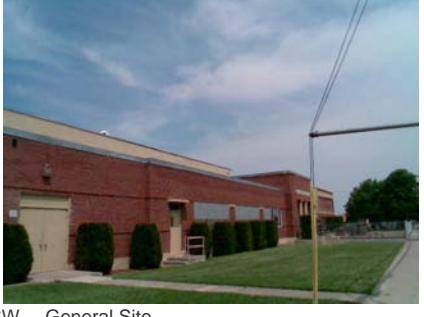
SW General Site Irregularities
