# M A Lynch Elementary School

Redmond SD 2J

## FEMA 154 Rapid Visual Screening Score Card

Rapid Visual Screening - Senate Bill #2 - Seismic Needs Assessment  
Oregon Department of Geology and Mineral Industries

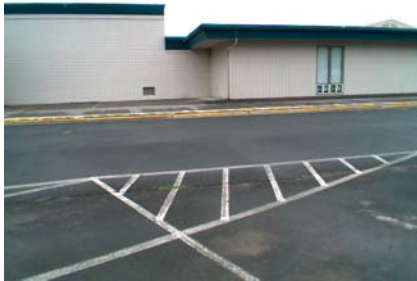
E Plan Irregularity Primary

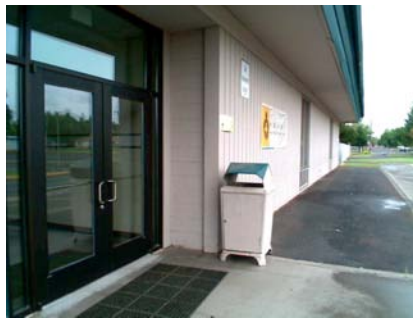
S Primary Structural Type

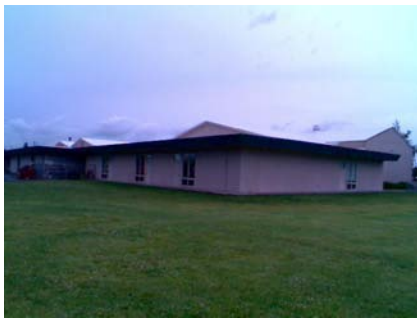
SW Vertical Irregularity Primary
