Tumalo Elementary School

Redmond SD 2J

FEMA 154 Rapid Visual Screening Score Card

Rapid Visual Screening - Senate Bill #2 - Seismic Needs Assessment
Oregon Department of Geology and Mineral Industries

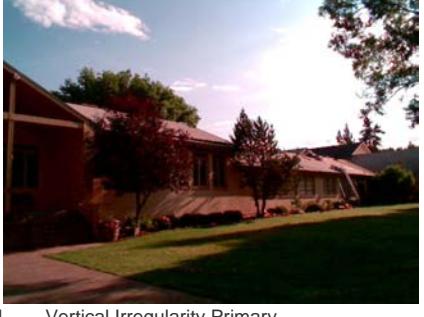
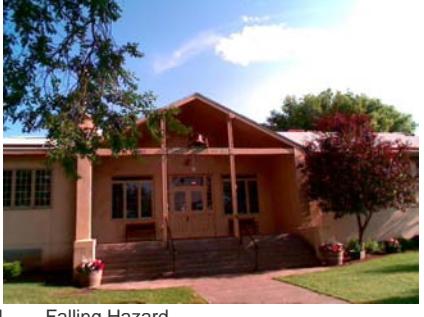
N Vertical Irregularity Primary		N Falling Hazard bell is a falling hazard; also building elevation; upgrade on roof and entry evidenced by wood framing on entry

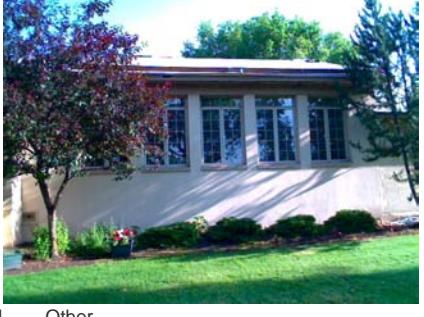
N Other sills and windows distinct from adjacent building; stucco has distinctive wear

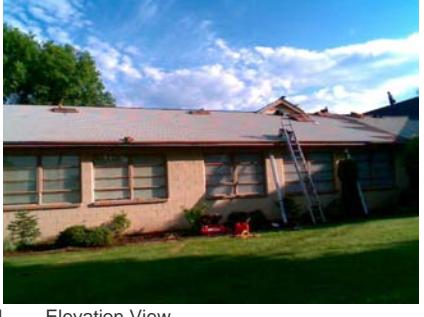
<p>N Elevation View age, structural type, left and right windows have diff. sills and there is a seam, possibly two buildings but so similar in construction, structural t</p>

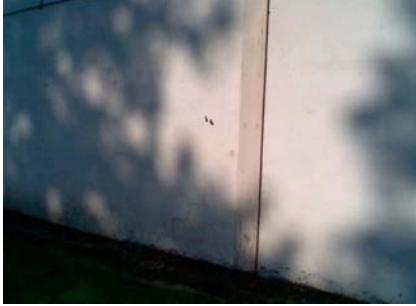
<p>W Primary Structural Type stucco cracking along cmu joints</p>

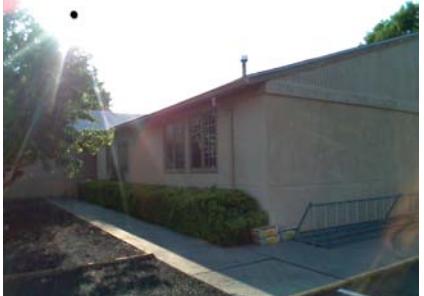
SW Plan Irregularity Primary
