# Sisters Middle School

Building Type		County	
School		Deschutes	
Street			
15200 Mckenzie Hwy			
City	State	Zip	
Sisters	OR	97759	
Latitude		Longitude	
44.29278		121.57132	
Tracking Code		Inspection Date	
RVS in 2006		6/28/2006

## FEMA 154 Rapid Visual Screening Score Card

Rapid Visual Screening - Senate Bill #2 - Seismic Needs Assessment  
Oregon Department of Geology and Mineral Industries

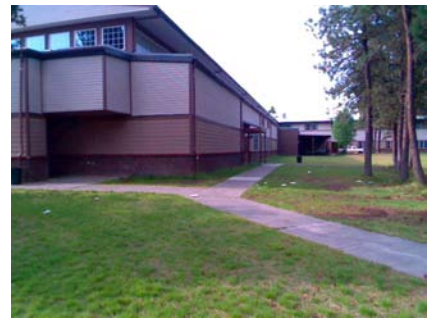
NW Plan Irregularity Primary  
t shape also some question about structural type
