Cascade Middle School

Bend-LaPine SD 1

Desc_sch29A

Rapid Visual Screening - Senate Bill #2 - Seismic Needs Assessment
Oregon Department of Geology and Mineral Industries

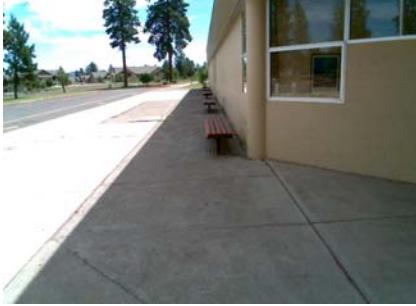
NW Primary Structural Type		NW Vertical Irregularity Primary

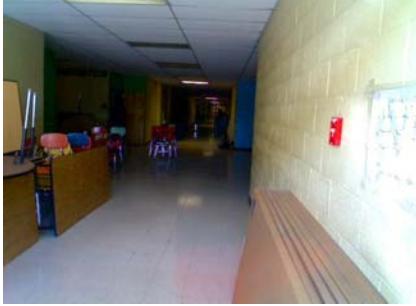
N Primary Structural Type

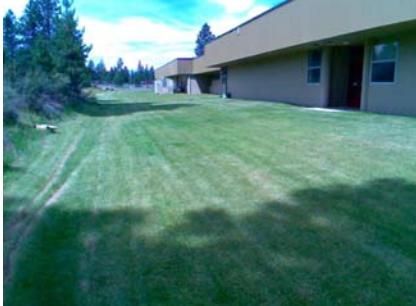
NE Plan Irregularity Primary		SE General Site

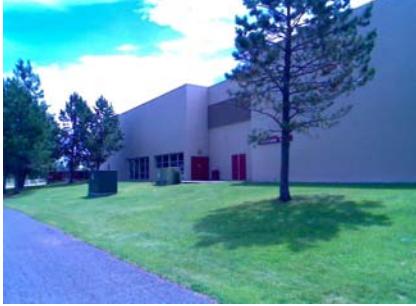
NW Plan Irregularity Primary
