Highland School at Kenwood Elementary School

Bend-LaPine SD 1

Desc_sch31A

Rapid Visual Screening - Senate Bill #2 - Seismic Needs Assessment
Oregon Department of Geology and Mineral Industries

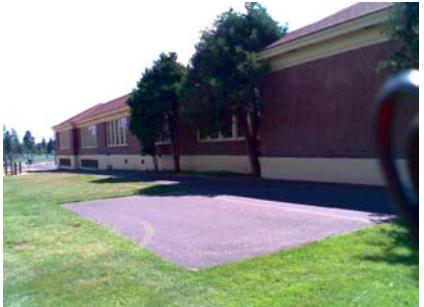
NE Vertical Irregularity Primary

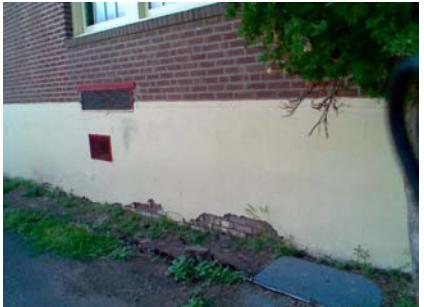
E Primary Structural Type

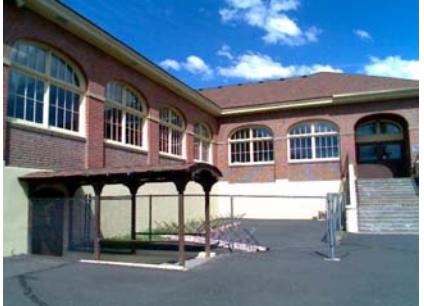
SE Plan Irregularity Primary

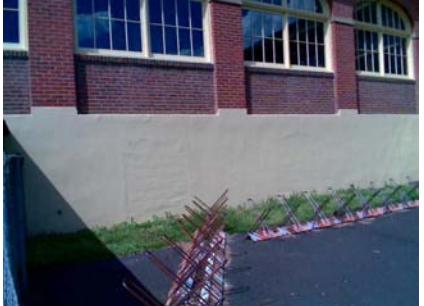
S Seismic Upgrade

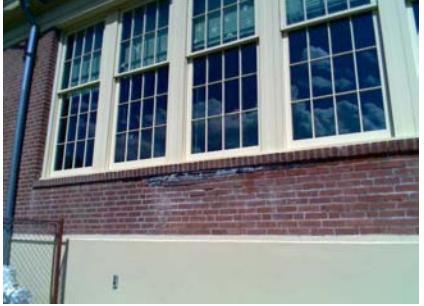
W Poor Condition

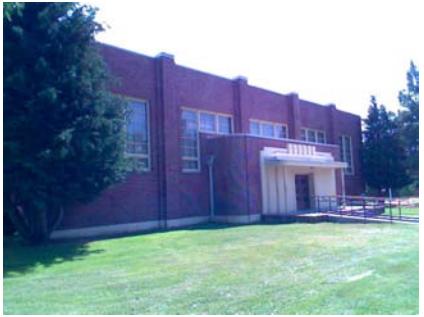
NE Plan Irregularity Primary
