Campus Center

Umpqua CC

Doug_coc01A

FEMA 154 Rapid Visual Screening Score Card

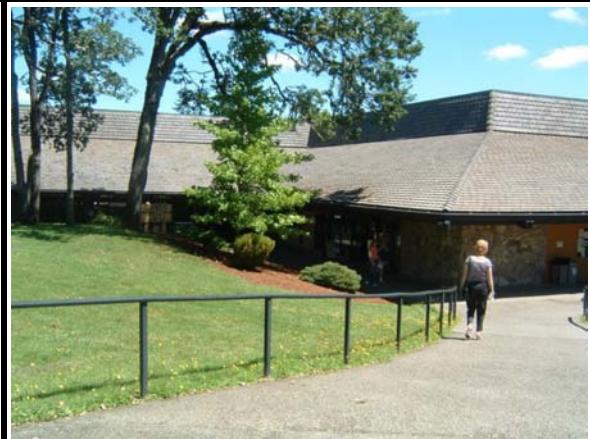
Type	Basic Score	Vert Irreg	Plan Irreg	Pre-Code	Post-Bench	Soil C	Soil D	Soil E	RVS Score
Primary	W2	3.8	-2	-0.5	0	0	0	0	0	1.3
Secondary		0	0	0	0	0	0	0	0	0
Tertiary		0	0	0	0	0	0	0	0	0

Final Type	Final Score
W2	1.3

Moderate (>1%)

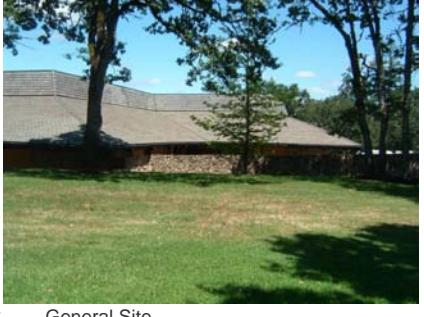
S	General Site	S	General Site

Enrollment	Year Built (Field Verified)	Year Built (Alt. Source)	Est. Decade Built
	1970	1970	1970
Total Area (square ft)	Number of Stories	Basement	Pounding Potential
25200	1	No	No
Plan Irregularities		Vertical Irregularities	
Yes: Unknown		None	
Falling Hazards		Poor Conditions	
None			
None			
None
