Ed. Skills Building

Umpqua CC

FEMA 154 Rapid Visual Screening Score Card

Rapid Visual Screening - Senate Bill #2 - Seismic Needs Assessment
Oregon Department of Geology and Mineral Industries

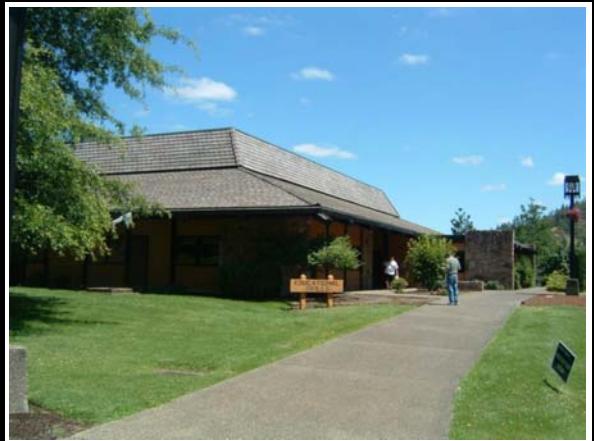
Type	Basic Score	Vert Irreg	Plan Irreg	Pre-Code	Post-Bench	Soil C	Soil D	Soil E	RVS Score
Primary	W2	3.8	-2	-0.5	0	-2.4	0	0	0	-1.1
Secondary		0	0	0	0	0	0	0	0	0
Tertiary		0	0	0	0	0	0	0	0	0

Final Type	Final Score
W2	-1.1

Very High (100%)
