Library

Umpqua CC

Building Type		County	
Community_College		Douglas	
Street			
1140 Umpqua College Rd			
City	State	Zip	
Roseburg	OR	97470	
Latitude		Longitude	
43.28929		123.33242	
Tracking Code		Inspection Date	
RVS in 2006		8/25/2006

Rapid Visual Screening - Senate Bill #2 - Seismic Needs Assessment
Oregon Department of Geology and Mineral Industries

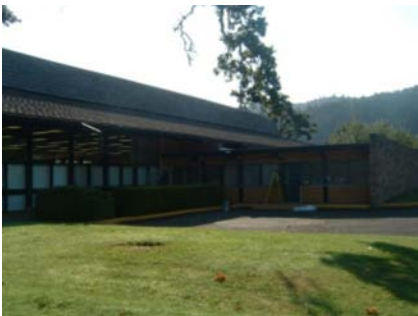
SW Plan Irregularity Primary

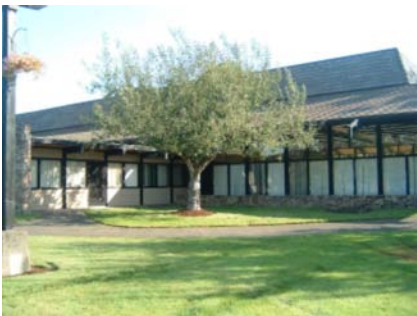
SE Primary Structural Type
