Whipple Fine Arts

Umpqua CC

Building Type		County	
Community_College		Douglas	
Street			
1140 Umpqua College Rd			
City	State	Zip	
Roseburg	OR	97470	
Latitude		Longitude	
43.29033		123.33503	
Tracking Code		Inspection Date	
RVS in 2006		8/25/2006

FEMA 154 Rapid Visual Screening Score Card

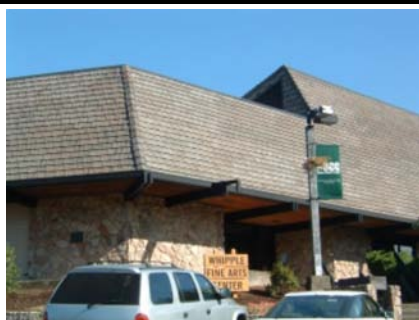
S Vertical Irregularity Tertiary

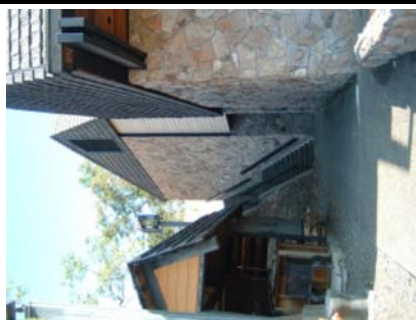
SW Vertical Irregularity Primary

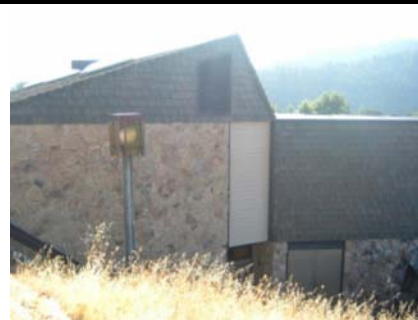
W Vertical Irregularity Tertiary

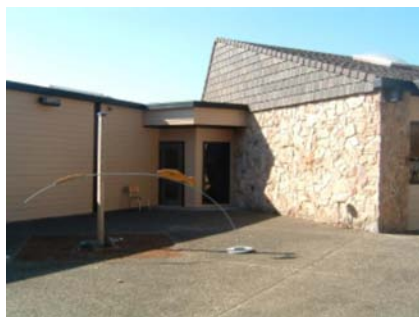
NE Plan Irregularity Primary
non-parallel system as well

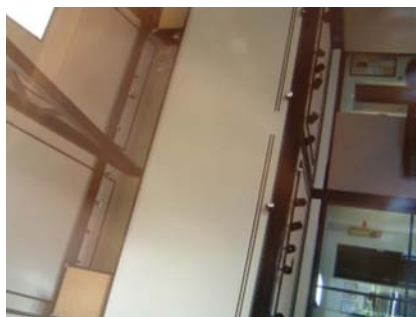
SW Vertical Irregularity Secondary

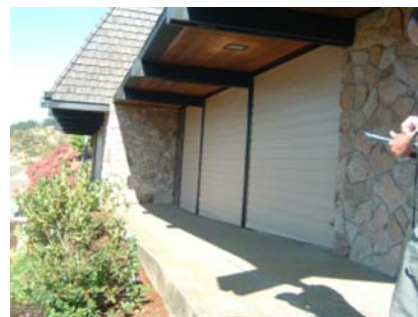
SE Plan Irregularity Tertiary
