Douglas County Fire District 2 - Dixonville Station #1

Doug_fir01A

FEMA 154 Rapid Visual Screening Score Card

Rapid Visual Screening - Senate Bill #2 - Seismic Needs Assessment
Oregon Department of Geology and Mineral Industries

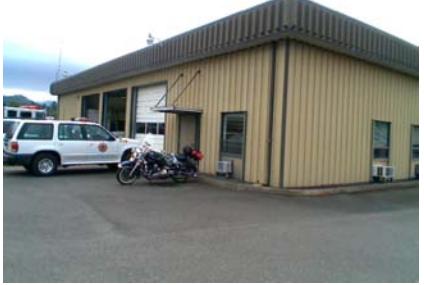
NW Primary Structural Type

Enrollment	Year Built (Field Verified)	Year Built (Alt. Source)	Est. Decade Built
			1970
Total Area (square ft)	Number of Stories	Basement	Pounding Potential
	1	No	No
Plan Irregularities		Vertical Irregularities	
None		None	
None		None	
None		None	
Falling Hazards		Poor Conditions	
None		None	
None		None	
None		None

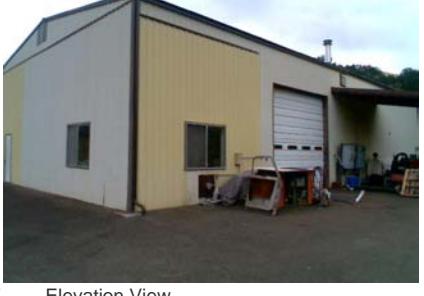
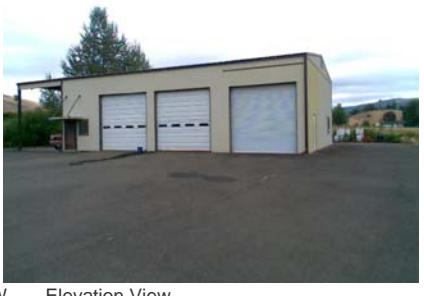
E	Elevation View	W	Elevation View

Enrollment	Year Built (Field Verified)	Year Built (Alt. Source)	Est. Decade Built
			1980
Total Area (square ft)	Number of Stories	Basement	Pounding Potential
	1	No	No
Plan Irregularities		Vertical Irregularities	
Torsion: Eccentric Stiffness		None	
None		None	
None		None	
Falling Hazards		Poor Conditions	
None		None	
None		None	
None		None
