North Douglas County Fire & EMS

Doug_fir02A

FEMA 154 Rapid Visual Screening Score Card

Rapid Visual Screening - Senate Bill #2 - Seismic Needs Assessment
Oregon Department of Geology and Mineral Industries

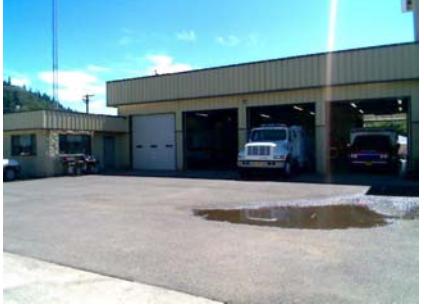
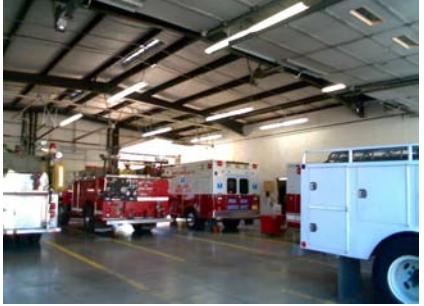
NW Plan Irregularity Primary		N General Site

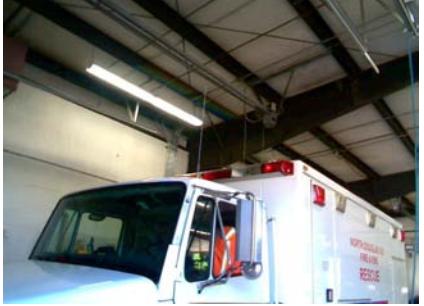
N Secondary Structural Type

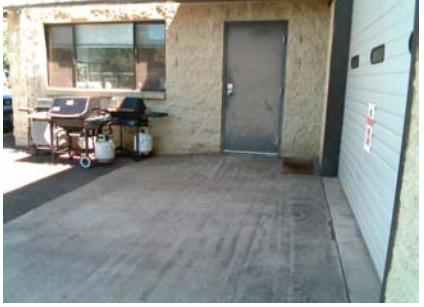
W Primary Structural Type

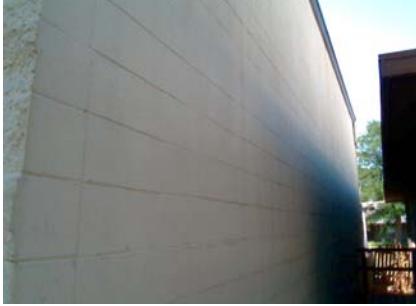
Enrollment	Year Built (Field Verified)	Year Built (Alt. Source)	Est. Decade Built
			1970
Total Area (square ft)	Number of Stories	Basement	Pounding Potential
	1	No	No
Plan Irregularities		Vertical Irregularities	
Torsion: Eccentric Stiffness		None	
None		None	
None		None	
Falling Hazards		Poor Conditions	
None		None	
None		None	
None		None

<p>N Plan Irregularity Primary Back wall is solid indicating a potential torsion problem.</p>
