# Reedsport FD Station 1

Building Type	County
Fire - City	Douglas
Street	
124 N 4th St	
City	State Zip
Reedsport	OR 97467
Latitude	Longitude
43.70179	124.09687
Tracking Code	Inspection Date
RVS in 2006	8/18/2006

## FEMA 154 Rapid Visual Screening Score Card

Rapid Visual Screening - Senate Bill #2 - Seismic Needs Assessment  
Oregon Department of Geology and Mineral Industries

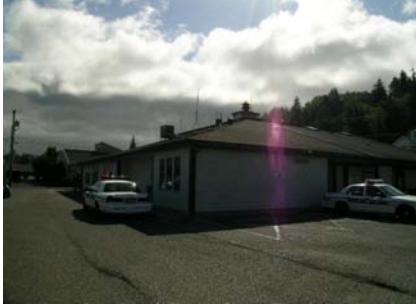
NW Elevation View		SE Plan Irregularity Secondary	
		Large openings, the back wall of this garage is solid RM indicating a potential Torsion problem.

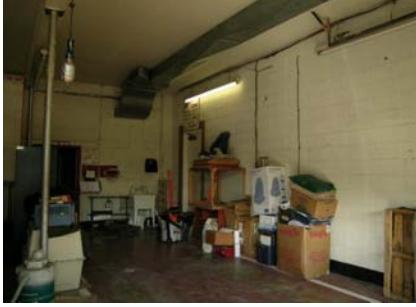
SE Secondary Structural Type RM walls make a 'C' shape.		NE Plan Irregularity Primary Out of plane lateral system and an elevation step.
