Elkton RFPD

Building Type		County	
Fire - RFPD		Douglas	
Street			
25537 Hwy 138W			
City	State	Zip	
Elkton	OR	97436	
Latitude		Longitude	
43.63406		123.56307	
Tracking Code		Inspection Date	
RVS in 2006		8/18/2006

FEMA 154 Rapid Visual Screening Score Card

Rapid Visual Screening - Senate Bill #2 - Seismic Needs Assessment
Oregon Department of Geology and Mineral Industries

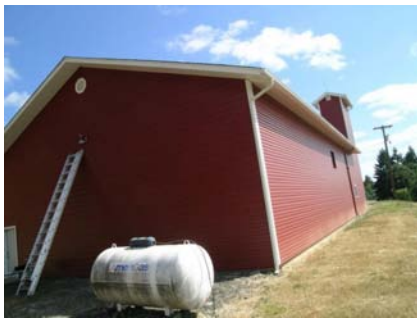
NW Vertical Irregularity Primary
due to hose tower

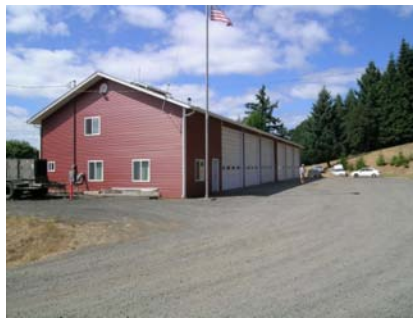
SW General Site
