# Fair Oaks RFPD

| RVS in 2006 | | 8/11/2006 | |

## FEMA 154 Rapid Visual Screening Score Card

Rapid Visual Screening - Senate Bill #2 - Seismic Needs Assessment  
Oregon Department of Geology and Mineral Industries

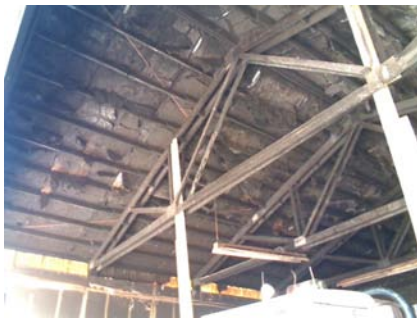
E Poor Condition  
fire damage

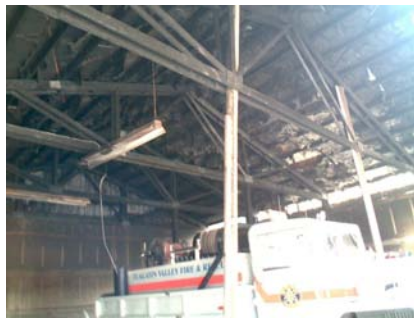
S Poor Condition  
fire damage

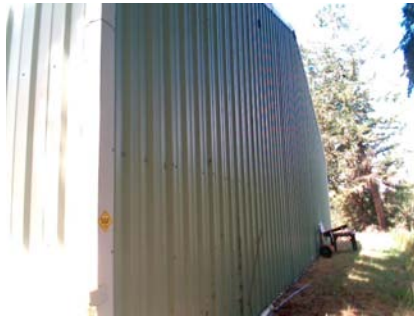
| Torsion: Eccentric Stiffness | None |

N Plan Irregularity Primary  
backwall solid indicating torsion problem
