# Lookingglass VFD

## FEMA 154 Rapid Visual Screening Score Card

Rapid Visual Screening - Senate Bill #2 - Seismic Needs Assessment  
Oregon Department of Geology and Mineral Industries

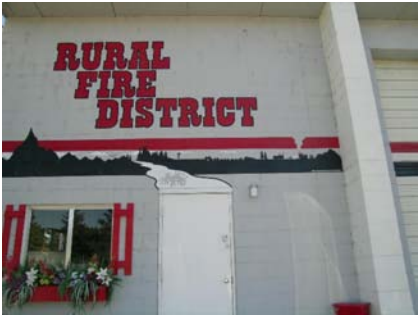
N Primary Structural Type

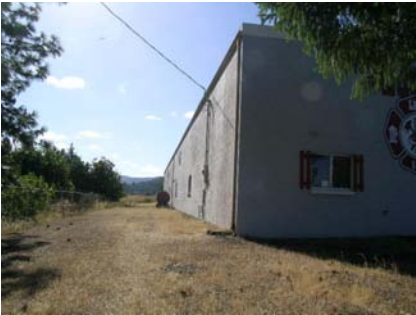
SE Elevation View
