Glendale FD #1

Doug_fir31A

FEMA 154 Rapid Visual Screening Score Card

Rapid Visual Screening - Senate Bill #2 - Seismic Needs Assessment
Oregon Department of Geology and Mineral Industries

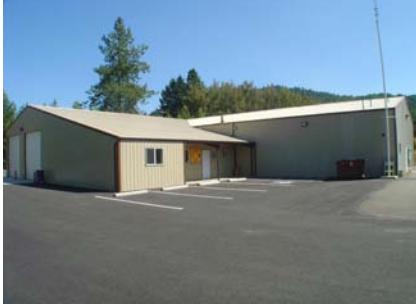
SW Plan Irregularity Primary
