Scottsburg RFPD

| Tracking Code RVS in 2006 | Inspection Date 8/18/2006 | |

FEMA 154 Rapid Visual Screening Score Card

Rapid Visual Screening - Senate Bill #2 - Seismic Needs Assessment
Oregon Department of Geology and Mineral Industries

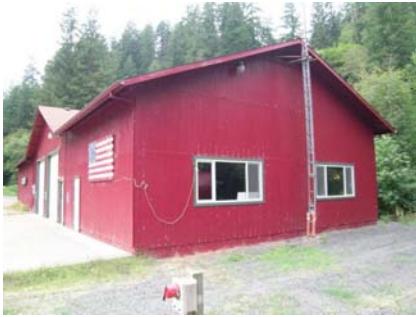
| | | SE Elevation View | |
