# Reedsport FD Station 2

City of Reedsport

## FEMA 154 Rapid Visual Screening Score Card

Rapid Visual Screening - Senate Bill #2 - Seismic Needs Assessment  
Oregon Department of Geology and Mineral Industries

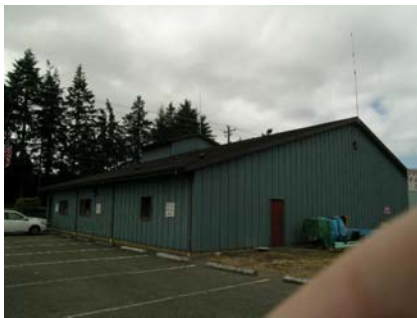
NE Primary Structural Type

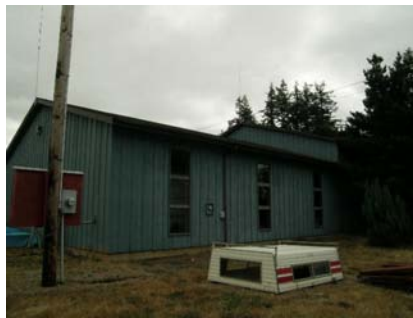
NW Vertical Irregularity Primary

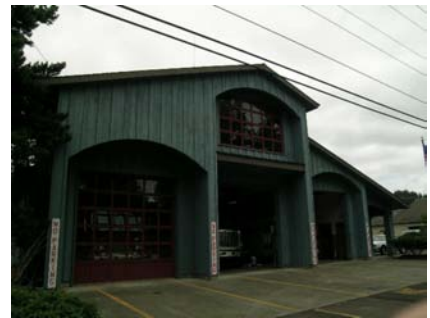
S Plan Irregularity Primary  
and # of stories
