Gardiner RFPD

Building Type Fire - RFPD	County Douglas	
Street 208 Marsh St		
City Gardiner	State OR	Zip 97441
Latitude 43.7321	Longitude 124.11077	
Tracking Code RVS in 2006	Inspection Date 8/18/2006

## FEMA 154 Rapid Visual Screening Score Card

Rapid Visual Screening - Senate Bill #2 - Seismic Needs Assessment  
Oregon Department of Geology and Mineral Industries

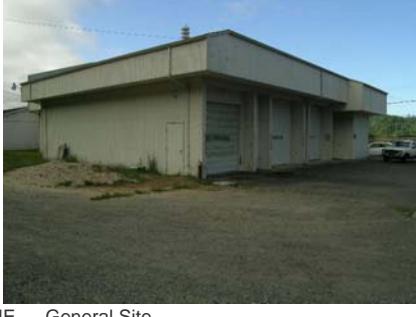
NE General Site		E Plan Irregularity Primary

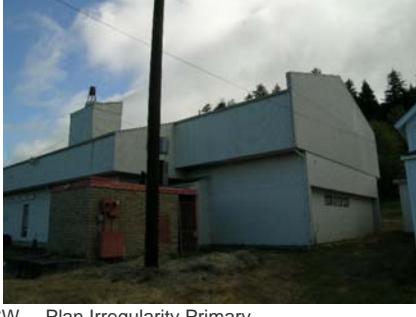
SW Plan Irregularity Primary

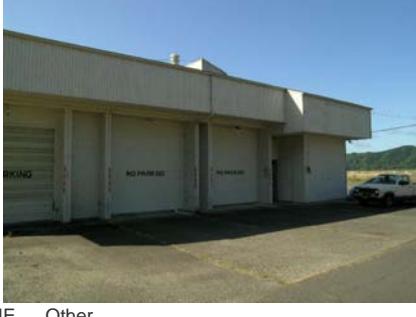
NE Other			
<p>no torsion due to section extending from the wall the bays are on.</p>
