North Douglas County Fire & EMS

Building Type	County	
Fire - RFPD	Douglas	
Street		
300 Curtin Park Rd		
City	State	Zip
Curtin	OR	97428
Latitude	Longitude	
43.72277	123.20902	
Tracking Code	Inspection Date	
RVS in 2006	8/9/2006

FEMA 154 Rapid Visual Screening Score Card

Rapid Visual Screening - Senate Bill #2 - Seismic Needs Assessment
Oregon Department of Geology and Mineral Industries

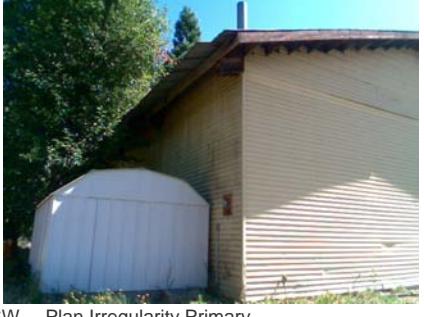
SW Plan Irregularity Primary back wall is solid: Torsion		SE General Site
