North Douglas Fire & EMS - Station #6

FEMA 154 Rapid Visual Screening Score Card

Rapid Visual Screening - Senate Bill #2 - Seismic Needs Assessment
Oregon Department of Geology and Mineral Industries

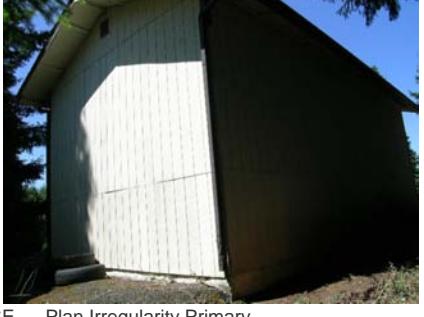
SE Plan Irregularity Primary back wall is solid indicating a possible torsion problem.
