# Sutherlin FD

City of Sutherlin

## FEMA 154 Rapid Visual Screening Score Card

Rapid Visual Screening - Senate Bill #2 - Seismic Needs Assessment  
Oregon Department of Geology and Mineral Industries

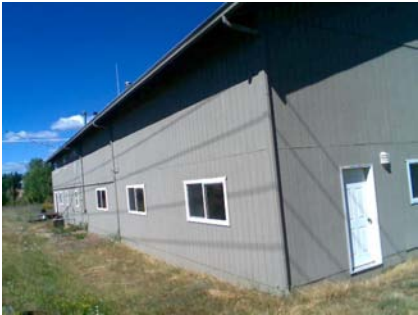
SW Plan Irregularity Primary  
back wall is solid indicating a potential torsion problem
