Lower Umpqua Hospital - Reedsport

Doug_hos02A

FEMA 154 Rapid Visual Screening Score Card

Rapid Visual Screening - Senate Bill #2 - Seismic Needs Assessment
Oregon Department of Geology and Mineral Industries

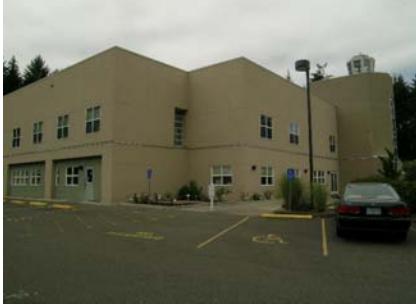
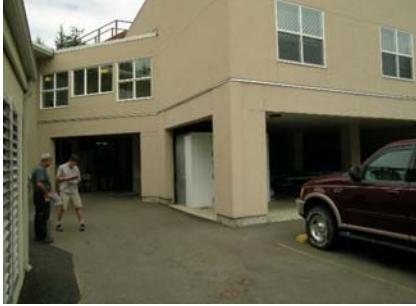
SE Vertical Irregularity Primary also shows the number of stories		S Vertical Irregularity Secondary soft story

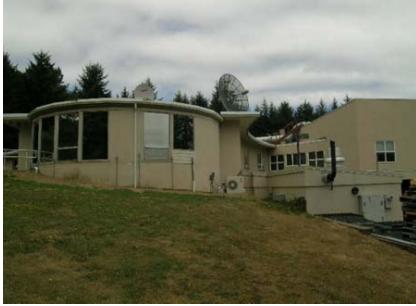
S Plan Irregularity Secondary and vertical irregularity- both due to adjacent structure.

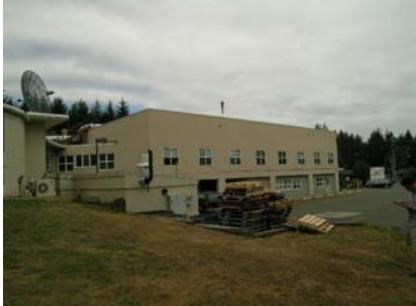
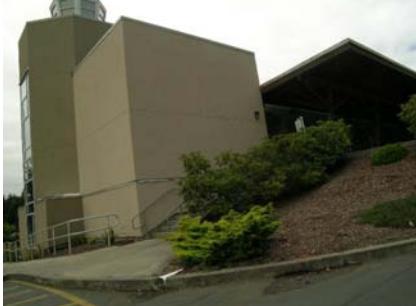
S General Site building A is on the right building B is on the left.		E Vertical Irregularity Tertiary sloped site

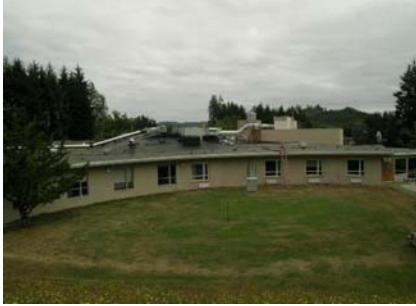
SW Plan Irregularity Secondary
