Douglas County Sheriff's Office

Doug_pol01A

FEMA 154 Rapid Visual Screening Score Card

Rapid Visual Screening - Senate Bill #2 - Seismic Needs Assessment
Oregon Department of Geology and Mineral Industries

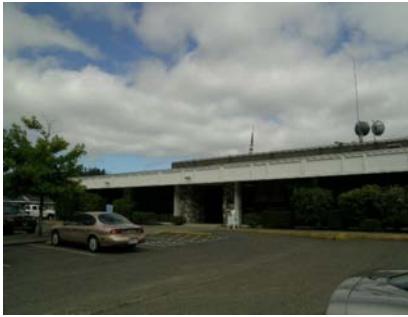
S	Falling Hazard	S	Vertical Irregularity Primary raised S3 section that gives the building increased head height through the center of the building. Thus, this irregularity also creates a large ope
