# Sutherlin Police Dept

Doug\_pol07A

## FEMA 154 Rapid Visual Screening Score Card

Rapid Visual Screening - Senate Bill #2 - Seismic Needs Assessment  
Oregon Department of Geology and Mineral Industries

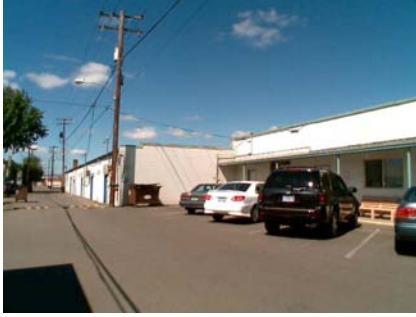
SE	Plan Irregularity Secondary reentrant corner due to adjacent building.	NW	Plan Irregularity Tertiary
