Reedsport Police Dept

Doug_pol08A

FEMA 154 Rapid Visual Screening Score Card

Rapid Visual Screening - Senate Bill #2 - Seismic Needs Assessment
Oregon Department of Geology and Mineral Industries

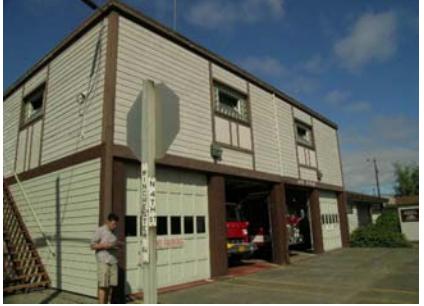
NW Elevation View		SE Plan Irregularity Secondary

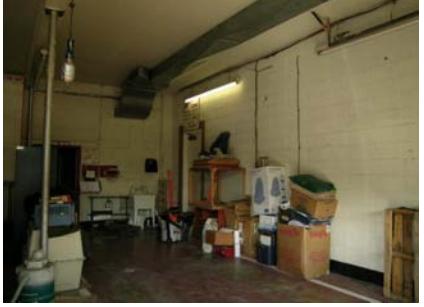
SE Secondary Structural Type RM walls on the sides and back of the garage form a "C" shape indicating a potential torsion problem.		NE Plan Irregularity Primary out of plane lateral system and elevation step.
