Douglas County Sheriff's Office and ERC - 911

Doug_pol10A

FEMA 154 Rapid Visual Screening Score Card

Rapid Visual Screening - Senate Bill #2 - Seismic Needs Assessment
Oregon Department of Geology and Mineral Industries

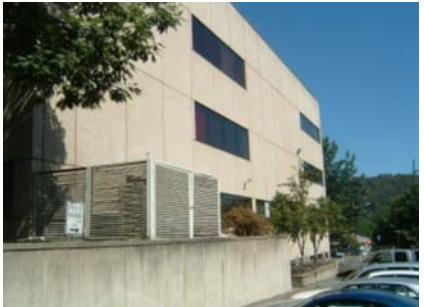
SE General Site

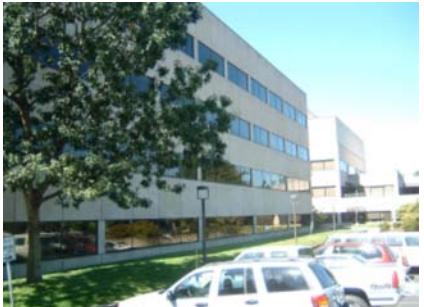
NE Plan Irregularity Primary steps in elevation also

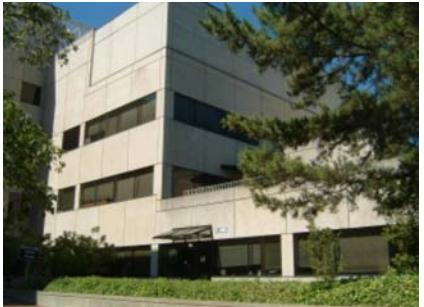
SW Vertical Irregularity Primary

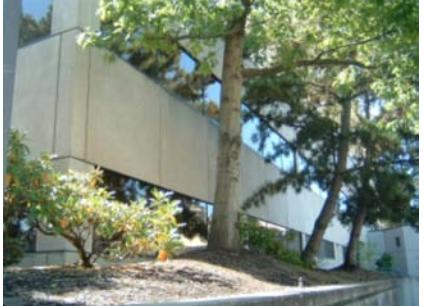
NW General Site
