# Eastwood Elementary School

Douglas County SD 4

## FEMA 154 Rapid Visual Screening Score Card

Rapid Visual Screening - Senate Bill #2 - Seismic Needs Assessment  
Oregon Department of Geology and Mineral Industries

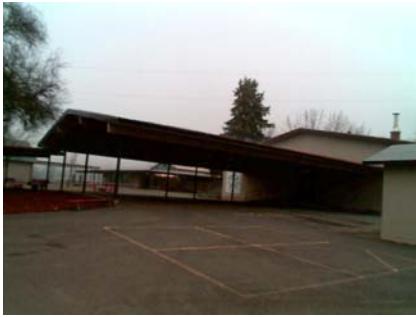
| NW Falling Hazard | | NW Secondary Structural Type | |

| Falling Hazards<br>Other: Ornamental Hazard Over Exit<br>None<br>None | | Poor Conditions<br>None<br>None<br>None | |

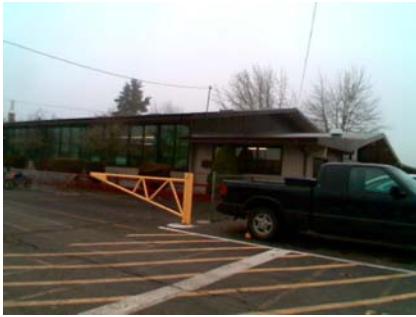
| | | SW Vertical Irregularity Primary | |

| Plan Irregularities<br>None<br>None<br>None | | Vertical Irregularities<br>Steps in Elevation View: Single Change<br>None<br>None | |

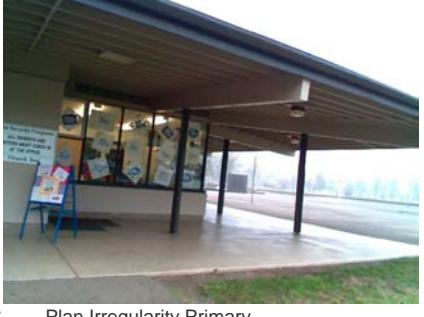
| | S Primary Structural Type | | S Plan Irregularity Primary | | E Elevation View |

| Out of Plane Lateral-Force-Resistance Elements | | Steps in Elevation View: Single Change | | | |
| Large Diaphragm or Central Opening | | None | | | |

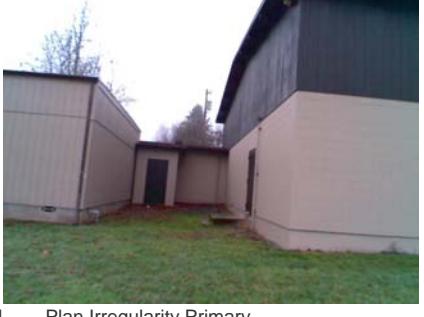
| N Plan Irregularity Primary | | NE Primary Structural Type | |

| Plan Irregularities<br>Reentrant Corners: Other<br>None<br>None | | Vertical Irregularities<br>Steps in Elevation View: 2 to 3 Changes<br>None<br>None | |
