# Fullerton IV Elementary School

Doug\_sch03A

## FEMA 154 Rapid Visual Screening Score Card

Rapid Visual Screening - Senate Bill #2 - Seismic Needs Assessment  
Oregon Department of Geology and Mineral Industries

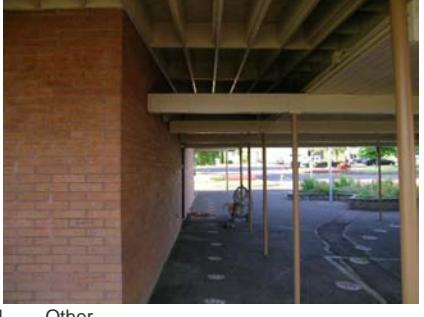
N Other <p>This building is attached to "B." The attachment however is really only holding the covered walkway. We did not specify an irregularity due to an ad</p>

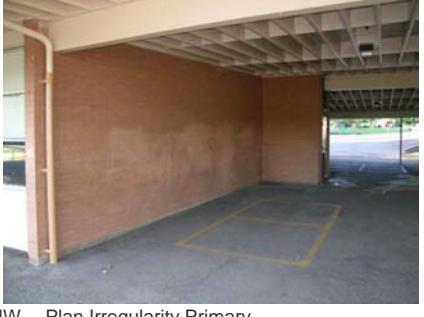
NW Plan Irregularity Primary

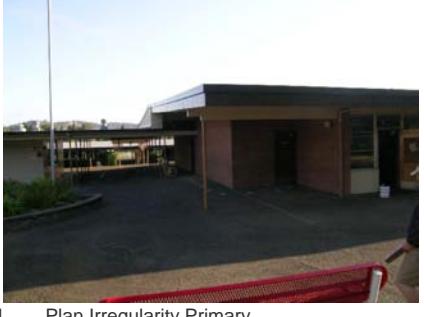
N Plan Irregularity Primary

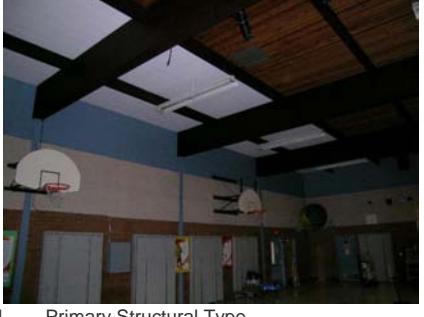
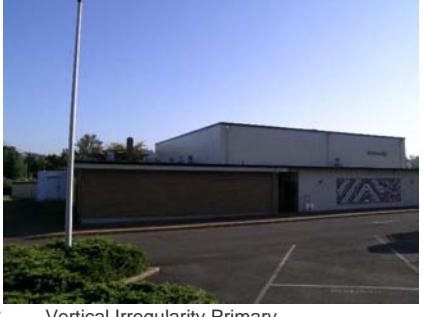
Enrollment 346	Year Built (Field Verified) 1961	Year Built (Alt. Source) 1961	Est. Decade Built 1960
Total Area (square ft) 31921	Number of Stories 1	Basement	Pounding Potential No
Plan Irregularities		Vertical Irregularities	
Out of Plane Lateral-Force-Resistance Elements None		Steps in Elevation View: Single Change Vertical Change in Structural Type (Soft over Stiff) None	
Falling Hazards		Poor Conditions	
Unreinforced Chimneys None		None	
None		None

N Primary Structural Type and secondary		S Vertical Irregularity Primary	
		W Falling Hazard Reinforced chimney? and out-of-plane offset
